Summerland Well Research Project Phase I Report

June 20, 2000

Phase I Project Report

Phase II-A Report

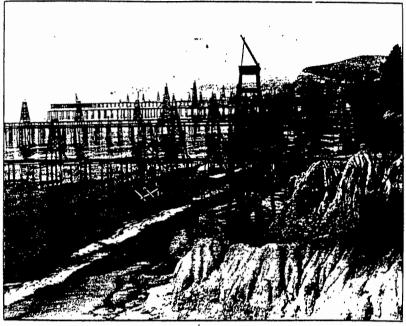
Officials say oil is seeping from some of the 165 abandoned wells, seen here in their production heyday, along the Summerland coast.

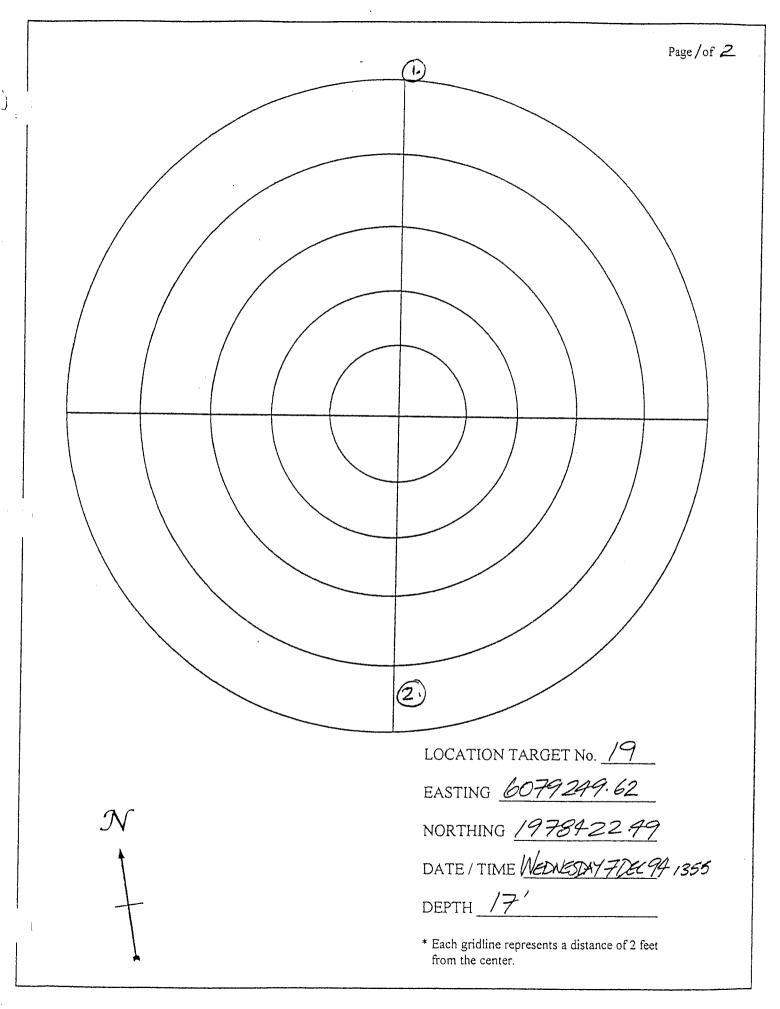
BOTTOM CONDITION AT THIS LOCATION
IS HARD PACKED SAND WITH OCCASIONAL
PATCHES OF ROCK AND HELP.
1) 2 × 8" WOOD PILINGS APPROXIMATELY
10' LONG, BEFORE THEY DISAPPEAR
INTO THE SEABED CLAYING ON THEIR
Sides.) AFTER A VISUAL SURVEY, DIVER
ATTER A VICUAL SURVEY Diver
Comment of ST A STATE WIEVE /, DIVER
COMPLETED A SECOND SEARCH WITH
THE UN METAL DETECTOR:
2) HOT SPOT, APPROXIMATELY 2'X4'.
Diver Dug 6" Dawn To ROCK,
No C- more Deposited to the Dies
NO CONTACTS REPORTED. AS THE DIVER
WAS DISCONNECTING THE UN METAL
DETECTOR, HE NOTICED THAT HIS
HANDS WERE COVERED WITH OIL. DUE
TO, POOR VISIBILITY, THIS WAS NOT
NOTICED AT TIME OF DICCOL ATTER
NOTICED AT TIME OF DIGGING . AFTER
FURTHER EXCAVATION, IT APPEARS
THE SEABED IS CONTAMINATED AT THIS
LOCATION

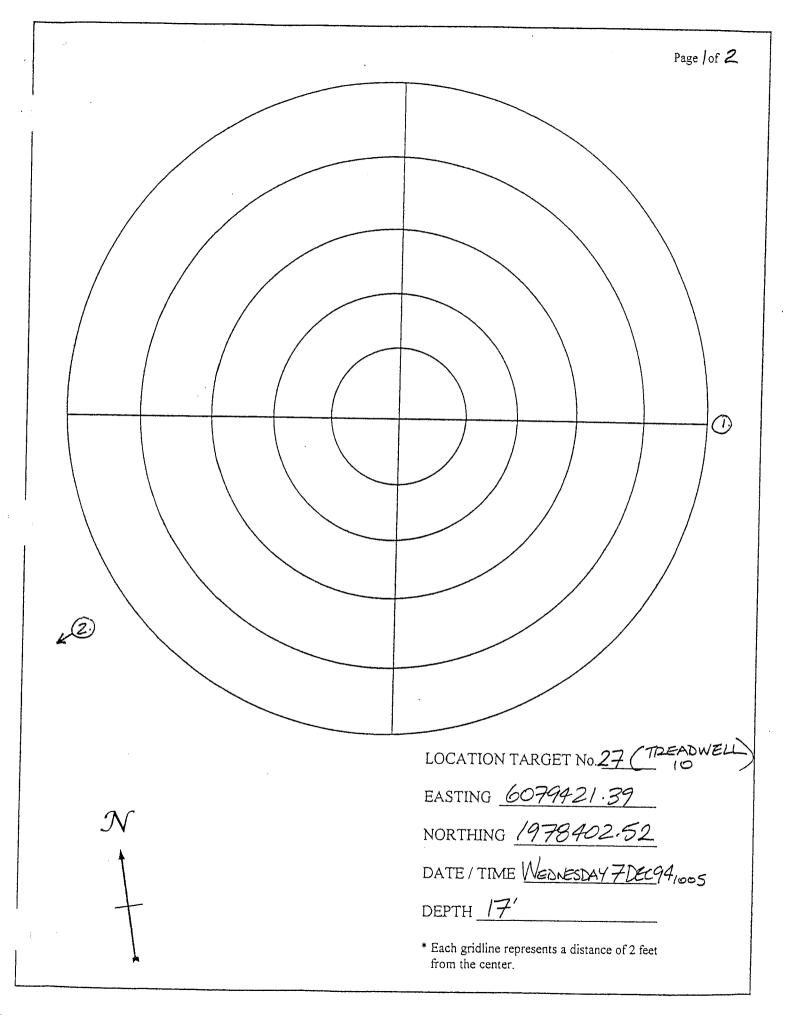
Para Chin Har in Anna
BOTTOM CONDITION HERE IS A MIXTURE
OF SAND TO THE GAST, THE REST
BEING ROCK WITH SCATTERED CLUMPS
OF KELP AND GROWTH. BOTTOM CONTOUR
VARIES, 1'TOZ' AT THIS LOCATION.
0,40,000
1) STEEL PLATE BURIED IN THE SAND,
WITH APPROXIMATELY 2"-3" OF EDGE
SHOWING UP OUT OF THE SEABLED.
The state of the s
6 20' To To Computer is a 20"
(3) 20' TO THE SOUTHWEST IS A 72"
Diameter Steel CASING. /TIS FILLED
Win A CONCRETE PLUG. DIE SEEPAGE
IS OBSERVED LEAKING THROUGH THE
PLUG, AROUND THE NORTH EDGE AND
UP TO A FOOT OR SO AWAY, COMING
UP THROUGH ROCKS ON THE BOTTOM!
GAS BUBBLES ALSO VISIBLE-Cominy
UP THOUGH A SEAM OF THE CASING-
W 5-12 D - (10/ 1/- 1/- 1-2)
* SPAR BUOY'C' NOW LOCATED AT THIS
AREA.
•

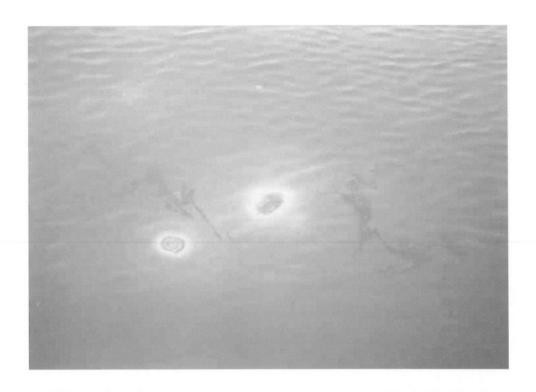
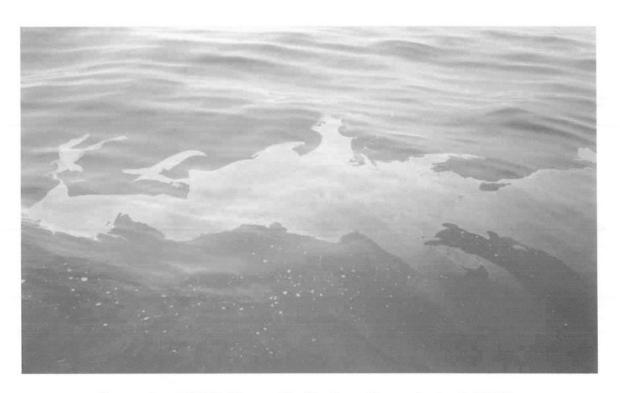
Examples Of Oil Sheen On Surface Upon Arrival At Site

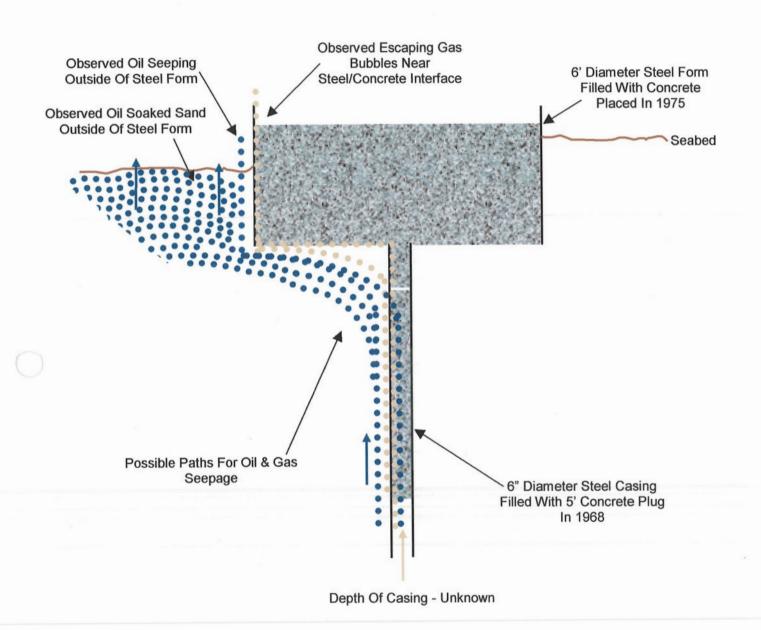
Elevation-View Section Illustrating Diver Observations And Possible Seep Paths

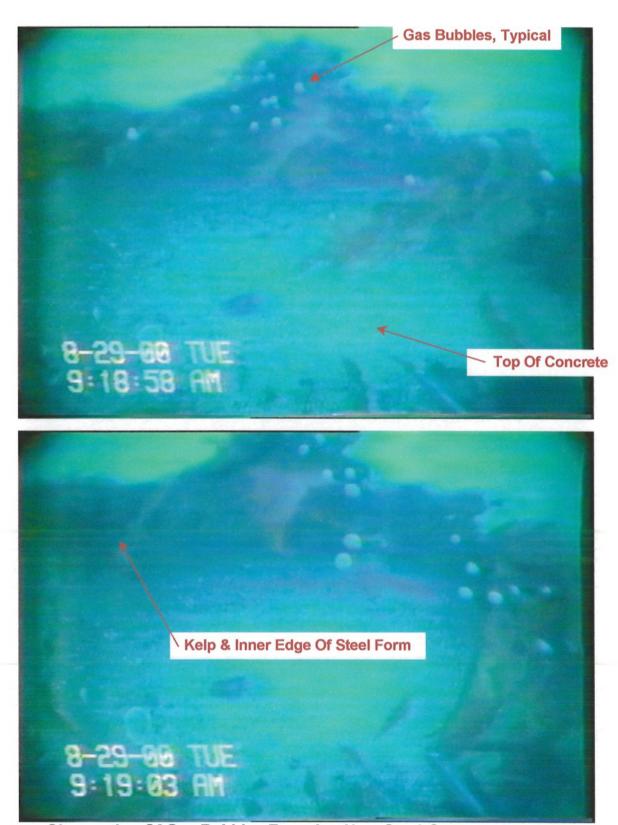
Observation Of Gas Bubbles Escaping Near Steel-Concrete Interface

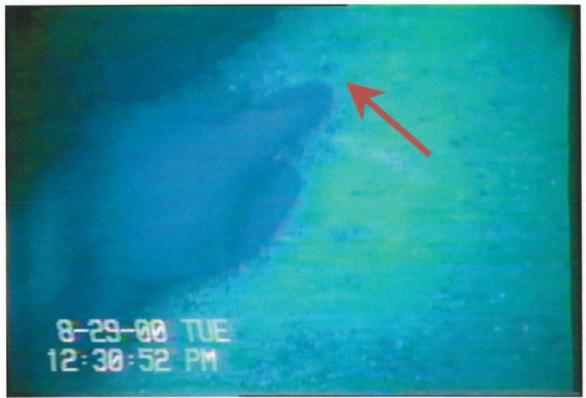
Observation Of Oil Droplet Forming In Sand Outside Steel Form

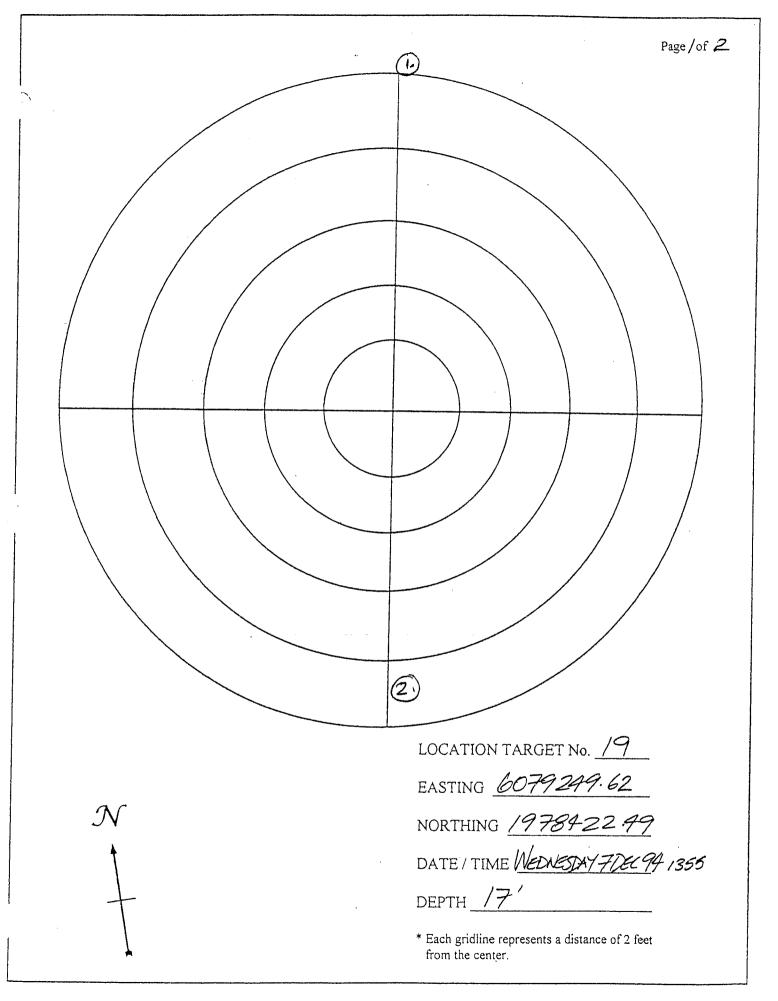
BOTTOM CONDITION AT THIS I - COT !!
BOTTOM CONDITION AT THIS LOCATION
IS HARD PACKED SAND WITH OCCASIONAL
PATCHES OF ROCK AND HELP.
5.
1) 2 × 8" WOOD PILINGS APPROXIMATELY
10' LONG, BEFORE THEY DISAPPEAR INTO THE SEABED. (LAYING ON THEIR
INTO THE SEABED. CLAYING ON FEIR
Sides.)
AFTER A VISUAL SURVEY, DIVED
COMPLETED A SECOND SEARCH WITH
THE YN METAL DETECTOR:
2) HOT SPOT, APPROXIMATELY 2'X4'.
NO CONTACTS PEROPTED. AS THE DIVER
WAS DISCONNECTING THE UN METAL
DEPECTOR, HE NOTICED THAT HIS
HANDS WERE COVERED WITH OIL. DUE
TO POOR VISIBILITY, THIS WAS NOT
NOTICED AT TIME OF DIGGING . AFTER
THE SEABED IS CONTAMINATED AT THIS
LOCATION

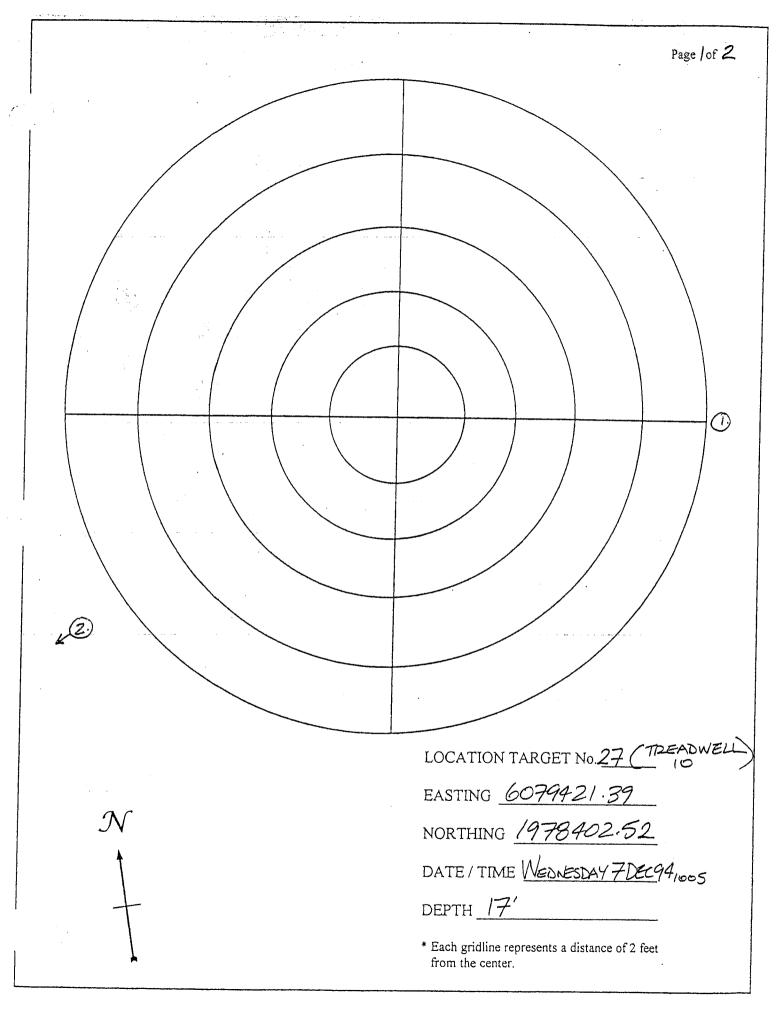
BOTTOM CONDITION HERE IS A MIXTURE
OF SAND TO THE GAST, THE REST
BEING ROCK WITH SCATTERED CLUMPS
OF KELP AND GROWTH. BOTTOM CONTOUR
VARIES, 1'TOZ' AT THIS LOCATION.
·
1) STEEL PLATE BURIED IN THE SAND,
WITH APPROXIMATELY 2"-3" OF EDGE
SHAVING UP OUT OF THE SEABLED.
(2) 20' TO THE SOUTHWEST IS A 72"
DIAMETER STEEL CASING. 17 15 FILLED
With A CONCRETE PLUG. DIE SEEPAGE
IS OBSERVED LEAKING THROUGH THE
PLUG, AROUND THE NORTH EDGE AND
UP TO A FOOT DO SO AWAY, COMING
UP THROUGH ROCKS ON THE BOTTOM.
GAS BUBBLES ALSO VISIBLE-COMING
UP THROUGH A SEAM OF THE CASING-
* SPAR BUOY'C' NOW LOCATED AT THIS
ADEA
//DEA
·
